# **Coastal Protection and Restoration Authority of Louisiana**

# **2011 Annual Inspection Report**

# NAOMI OUTFALL MANAGEMENT

State Project Number BA-3c Priority Project List 5

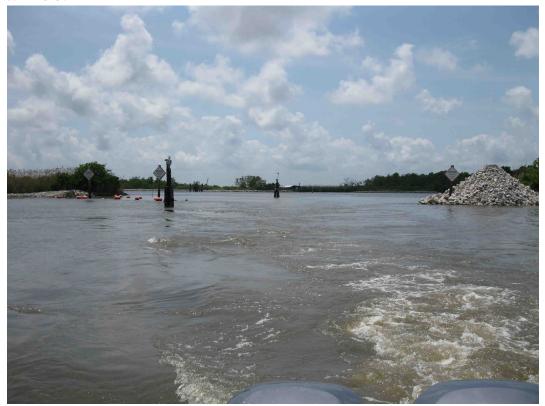
The structure has been altered to facilitate construction of the South Shore of the Pen (BA-41) Project. Rock has been temporarily removed from the weir and stored within the footprint of the structure (Photo #1). The structure will be replaced as designed at a later date.

**Photo #1 – Bayou Dupont Canal Weir.** Looking out from the Pen.

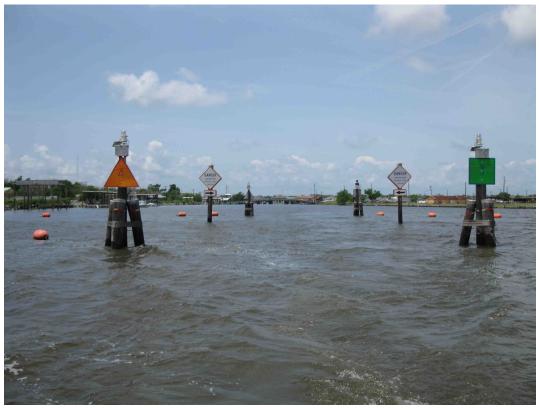
Some of the signs are losing their lettering due to weathering (Photo #2). The orange warning buoys on the north side came loose from the temporary repair and were repaired again before the inspection.

**Photo #2 – Goose Bayou Canal Weir.** Looking West.
